MNMM Fatal 2006-14

- Falling Material
- June 12, 2006 (Virginia)
- Crushed Stone Operation
- Machine/Plant Operator
- 39 years old
- 14 months mining experience

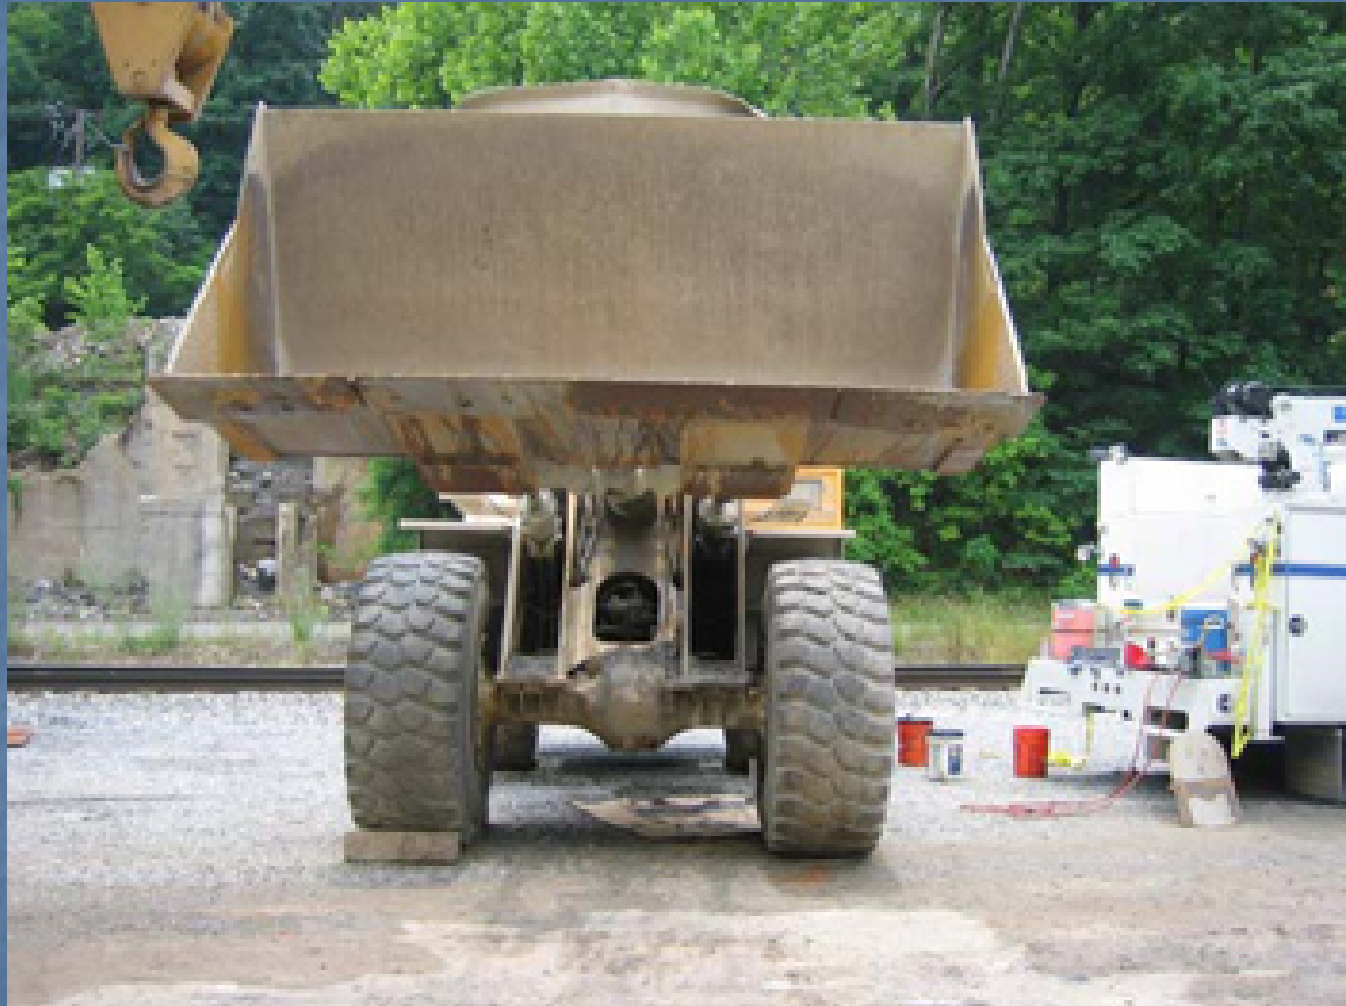
The victim was fatally injured while starting to repair a hydraulic line on a front-end loader that was parked outside of the shop. He was underneath the raised boom, loosening a hydraulic connection, when the boom arms fell, pinning him against the frame.

- A risk assessment to determine all possible hazards and to establish safe work procedures was not conducted prior to repairing a hydraulic line on a front-end loader. No procedures were in place to ensure that persons could safely perform maintenance tasks on mobile equipment. The raised components of the front-end loader were not blocked to prevent hazardous motion.
- Standards and controls were inadequate and failed to ensure that training regarding maintenance on mobile equipment was provided to persons before performing the task.

- Stop, Look, Analyze, and Manage (SLAM) each task to identify all potential hazards before performing maintenance work. Practice safe work habits during the entire task.
- Consult and follow the manufacturer's recommended safe work procedures for the maintenance task.
- Train miners in safe work procedures before beginning repairs.
- Securely block equipment against all hazardous motion at all times while performing maintenance work.
- Never travel or work under a raised loader bucket.
- Never loosen hydraulic hoses or components without first determining if they may be holding something up or trapping pressure.
